AIRCRAFT ACCIDENT INVESTIGATION BUREAU

INVESTIGATION REPORT ON

ACCIDENT TO THE B737-MAX8 REG. ET-AVJ OPERATED

Report No. AI-01/19
Pub, Date December 23, 2022

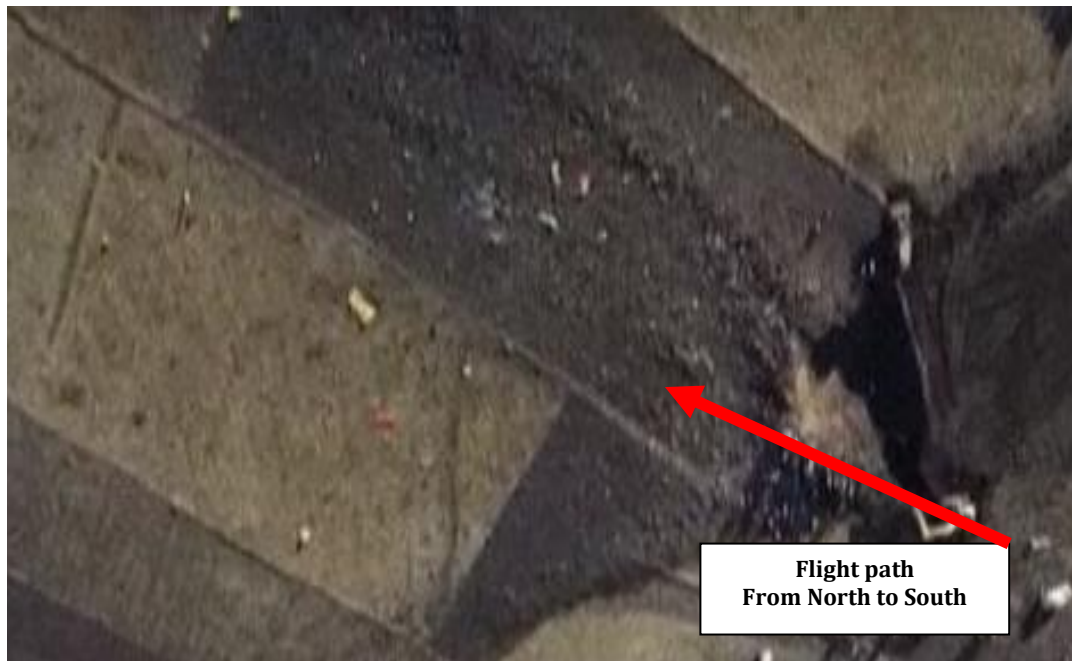
FIGURE 40: TOP VIEW OF THE CRATER

The Airplane impacted terrain at a farm field and created a crater approximately 10 meters deep (last Airplane part found) with a hole of about 28 meters width and 40 meters length. Most of the wreckage was found buried in the ground; small fragments of the Airplane were found scattered around the site in an area about 200 meters wide and 300 meters long. Damages to the Airplane were consistent with a high energy impact.

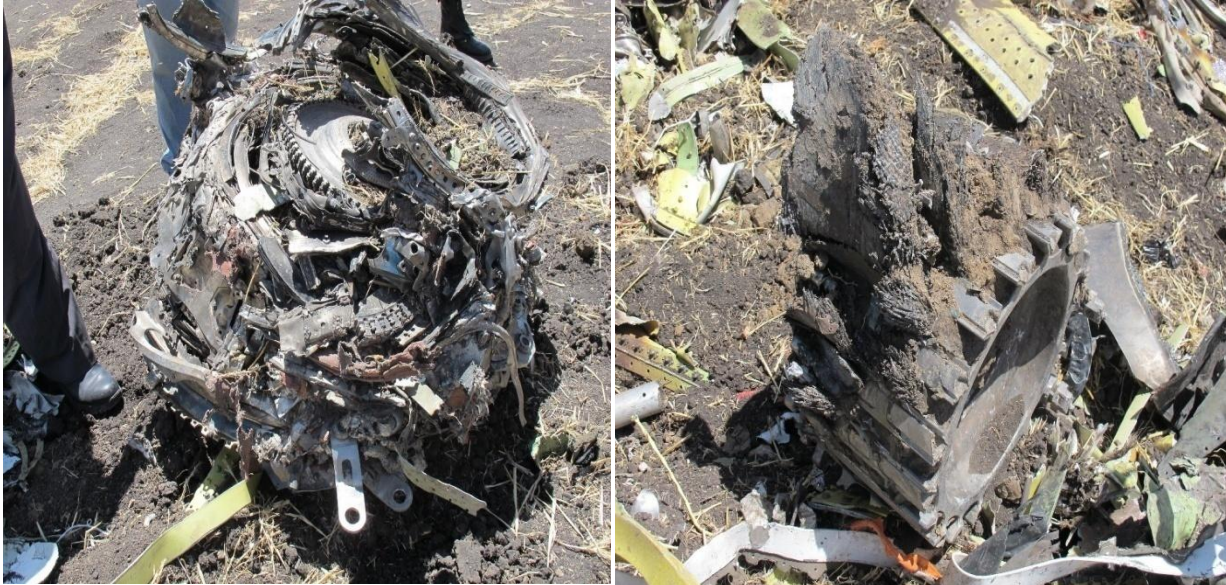
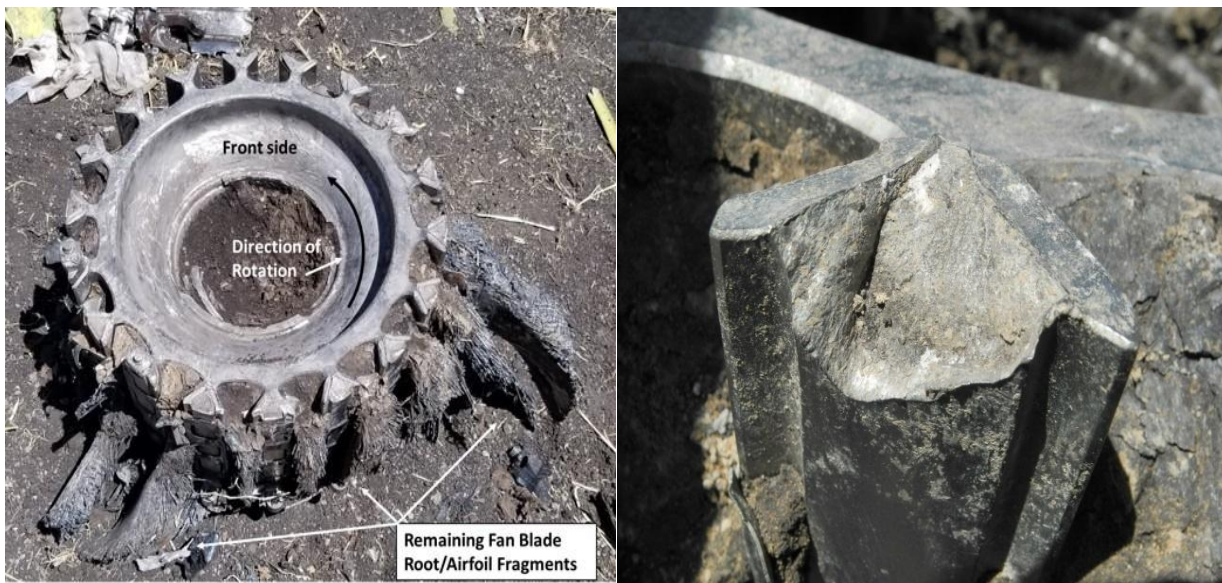
FIGURE 44: R/H ENGINE - S/N 602695 - CORE FIGURE 45: - R/H ENGINE - S/N 602695 - FAN DISK

The predominant feature of the deformation of the entire remaining core was axial deformation.

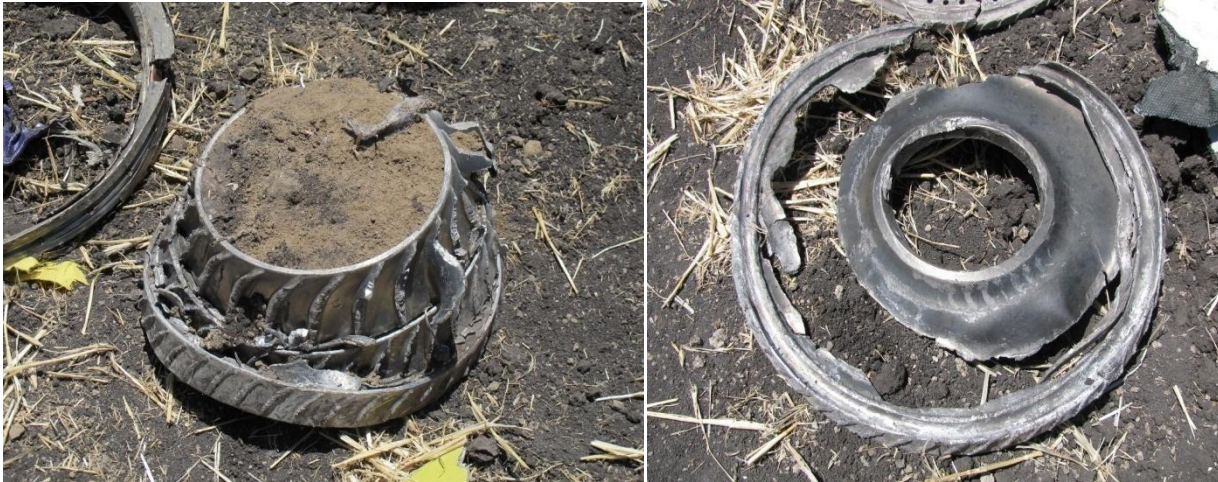
FIGURE 48: - R/H ENGINE - S/N 602695 - HPC STAGES 1 TO 3 FIGURES 49:- R/H ENGINE - S/N 602695 - HPC STAGE 7

6th, and the 8th to 10th stages were not found. The 5th stage was found separately, and it was also missing its airfoils. The 7th stage web was fractured circumferentially. The stator sections could not be identified.

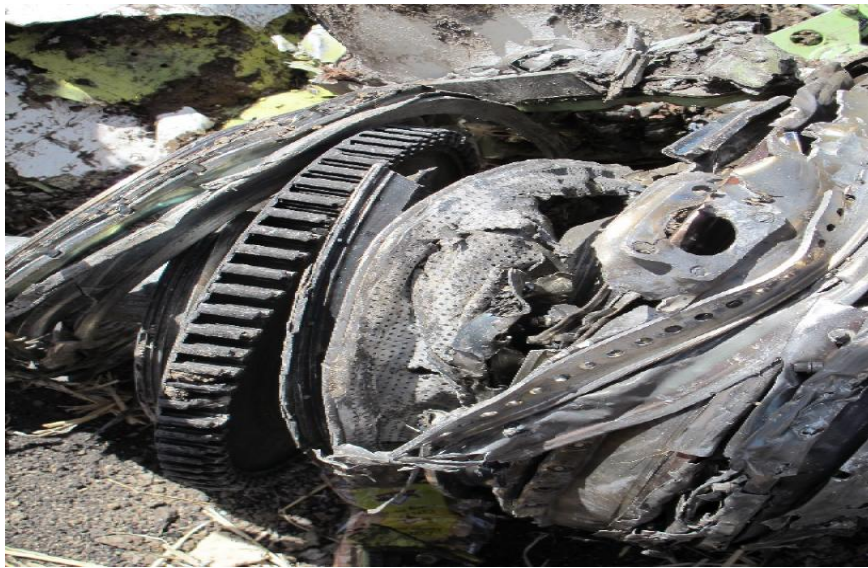
FIGURE 50: COMBUSTOR CRASHED

The combustor was severely crushed and most of it was missing into pieces.

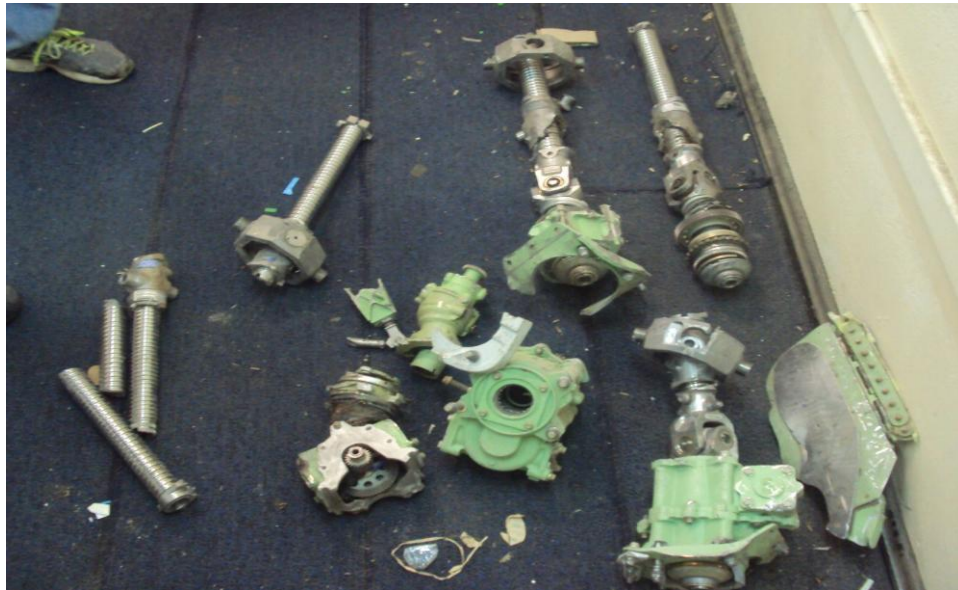
FIGURE56: TRAILING EDGE FLAP TRANSMISSIONS AND BALL SCREWS

During the examination of the wreckage pile located at the Addis Ababa airport EAIB store, the Airworthiness group identified a total of 4 (including the ones identified at the impact site) trailing edge flap transmissions (there are 8 total); three of these had the ball nut and gimbal still attached.

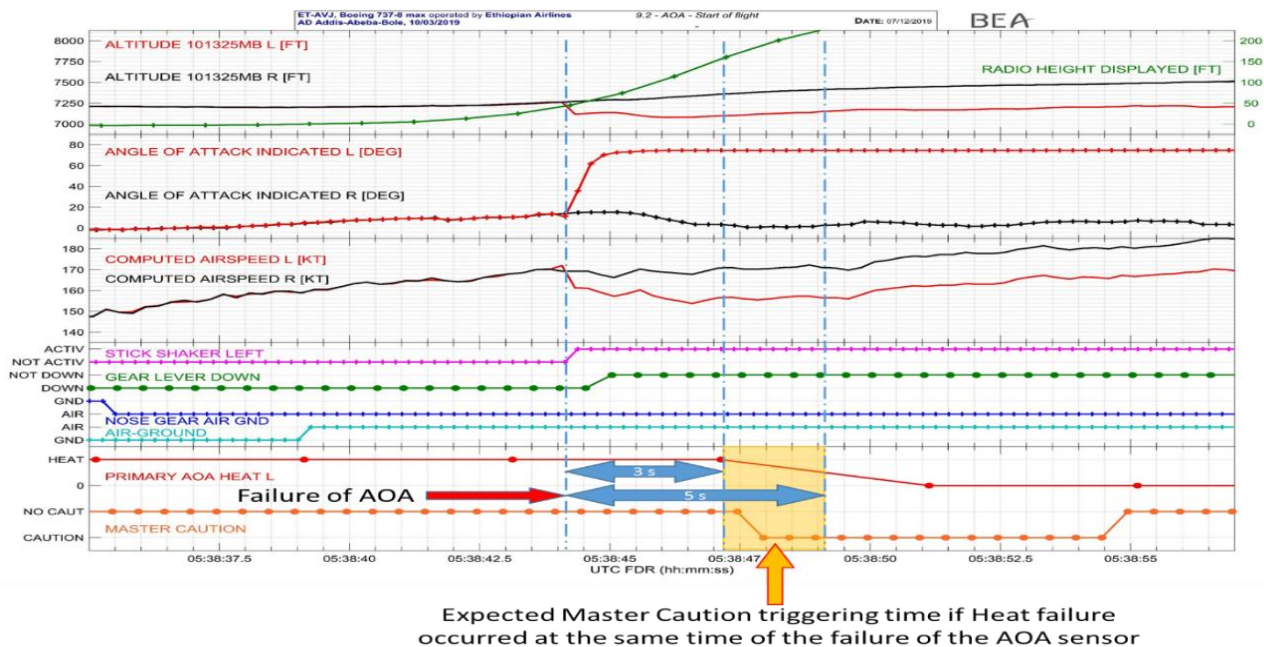
FIGURE 67: AOA VALUES DURING THE BEGINNING OF THE FLIGHT

From the CVR transcript, at 5 h 42 min 48 s, the Captain requested the recall of the master caution. At that time, master caution had only triggered once. Following the master caution recall, the crew exchanged “Master Caution Anti Ice” and “Left Alpha Vane”.

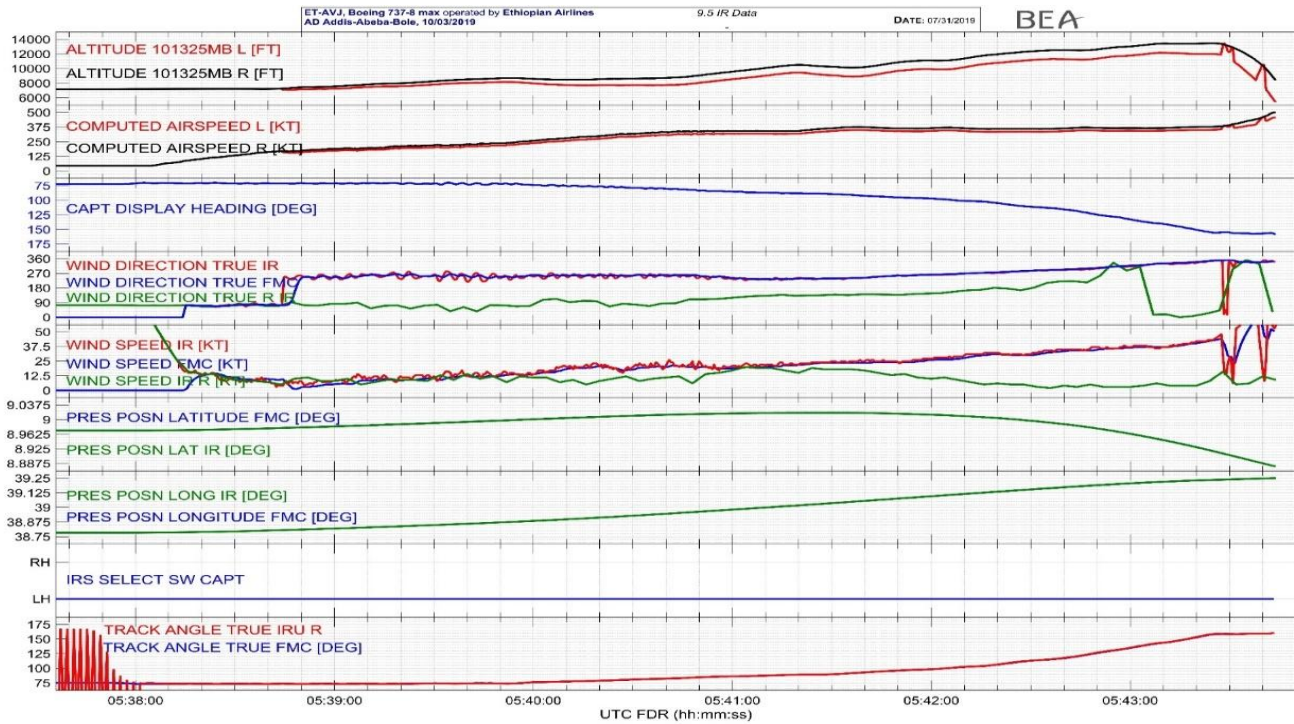
FIGURE70: IMPACT OF AOA FAILURE ON THE WIND COMPUTED VALUES

Most of the recorded IRS parameters did not show any variation following the AOA failure. On the contrary, the computed wind, on the left side, was clearly affected by that failure.

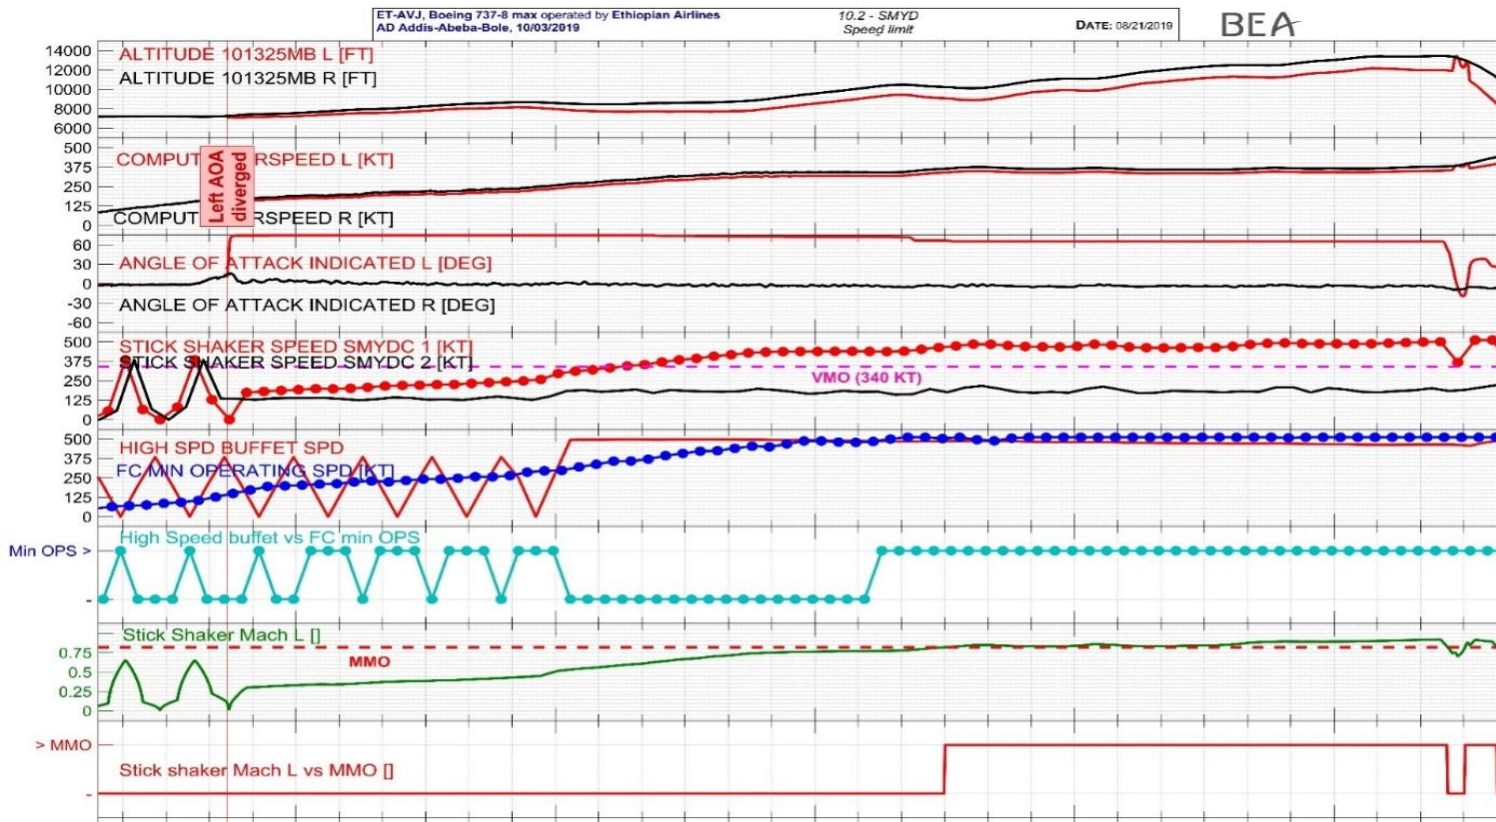
FIGURE 75: SMYD COMPUTED SPEEDS LIMITS

At 5 h 41 min 17 s, SMYDC1 computed FC minimum operational speed values greater than High speed buffet speed values. Both values were computed by the same computer SMYDC 1.

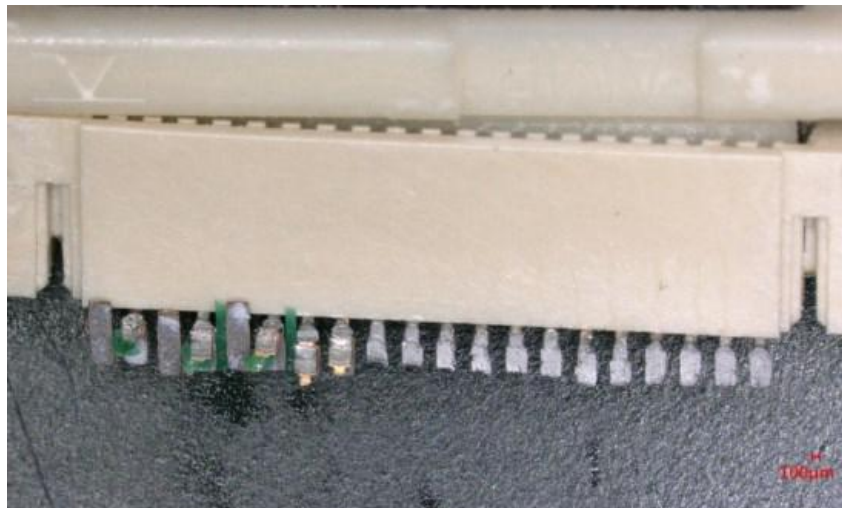
Figure5: Pads and pieces of PCB material on the connector pins
